Methode
RCRA Permit
9199

DOCUMENTATION OF ENVIRONMENTAL INDICATOR DETERMINATION

Migration of Contaminated Groundwater Under Control

Methode

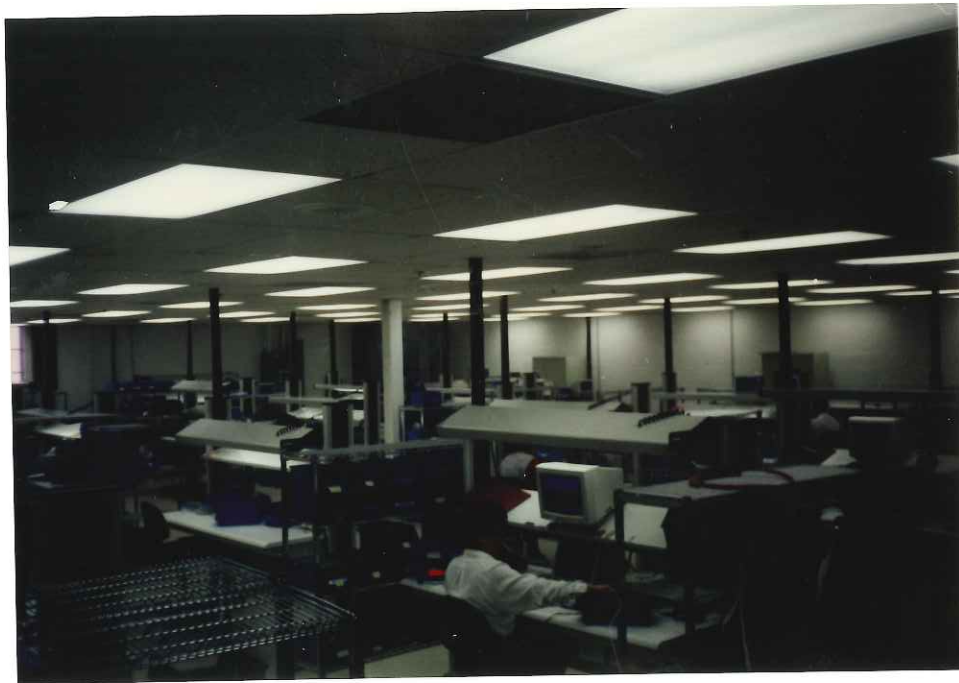
Photograph No. 2
 Orientation: Northeast
 Description: Former location of the former printed circuit board treatment area.

The former printed circuit board treatment area (SWMU 2) now houses work space for assembly. Until June 1981, this unit managed hazardous wastes in five above-ground tanks. The tanks and all associated equipment and piping were decontaminated and removed before the unit was remodeled.

Observations: This unit contained work spaces for assembly of purchased components during the VSI. The sealed concrete floor has been replaced with tile. No evidence of release was noted.

Location: SWMU 2
 Date: 2-20-92

Recommendations: BVWST recommends the concrete floor be sampled and the unit be RCRA closed.

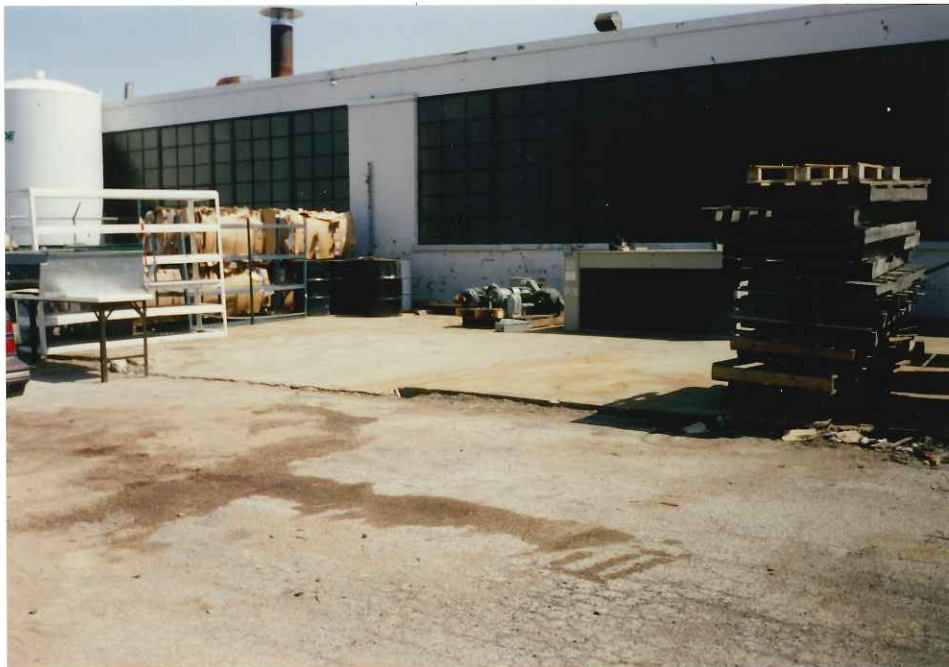
Photograph No. 3
 Orientation: South
 Description: Drummed hazardous waste storage occurred on the concrete pad.

Observations: The unit stored wooden pallets during the VSI. The concrete pad had some surficial cracks. The unit has been inactive since 1981. Visual evidence of release was not apparent.

Location: SWMU 3
 Date: 6-11-92

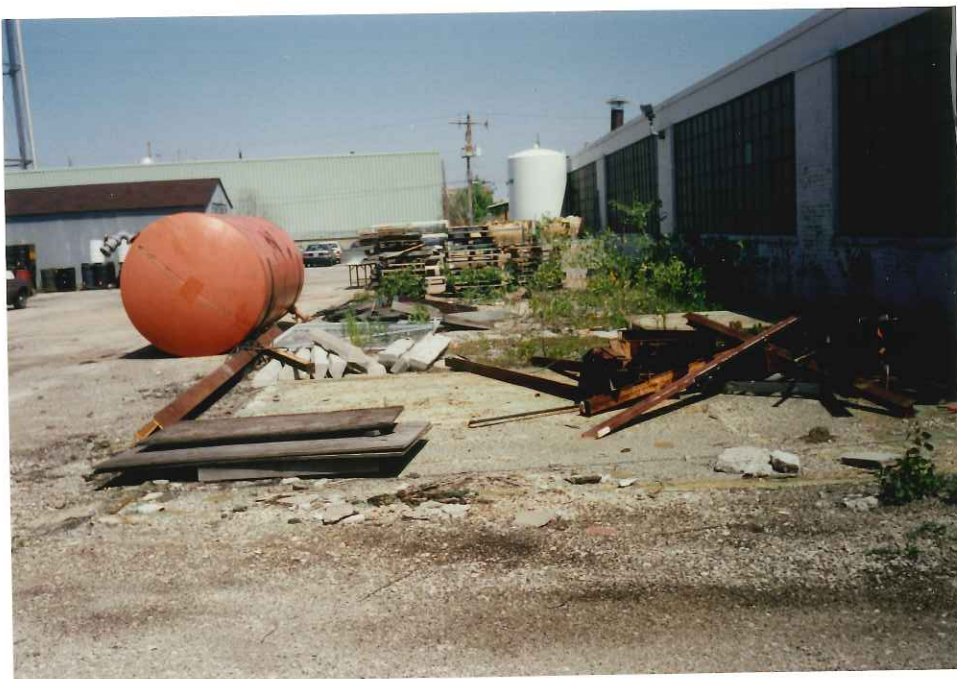
Photograph No. 4

Observations: The unit stored metal scraps and boards during the VSI. Surficial cracks were observed in the concrete. Visual evidence of release was not apparent.

Description: Hazardous wastes were stored in tanks on this concrete pad.

Location: SWMU 4

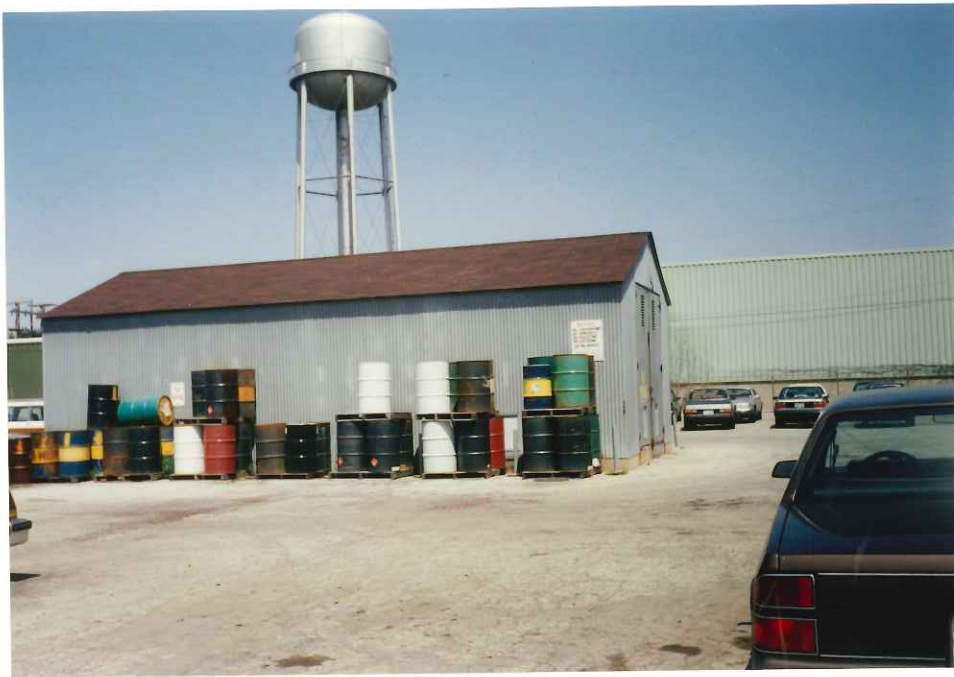
Photograph No. 6
Orientation: East
Description: Storage Shed.

Location: SWMU 5
Date: 6-11-92
